# A SPLENDID WELCOME TO THE ‘HOUSE OF PRAISES, GLORIOUS DEEDS AND MAGNANIMITY’

Mechthild Baumeister, Beth Edelstein, Adriana Rizzo, Arianna Gambirasi, Timothy Hayes, Roos Keppler and Julia Schultz

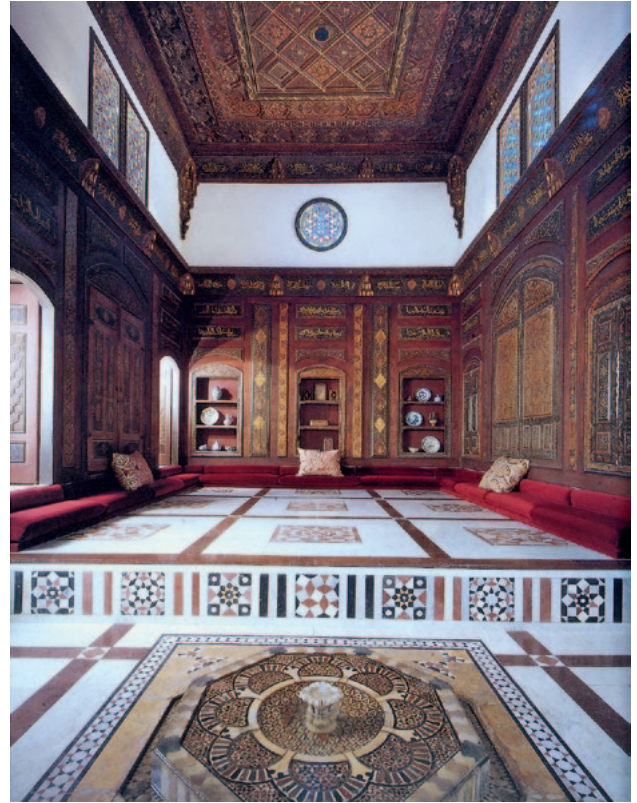
Fig. 1 Nur al-Din Room as installed in the 1970s in the Islamic art galleries. The Metropolitan Museum of Art, Gift of The Hagop Kevorkian Fund 1970 (1970.170). Image: © The Metropolitan Museum of Art.

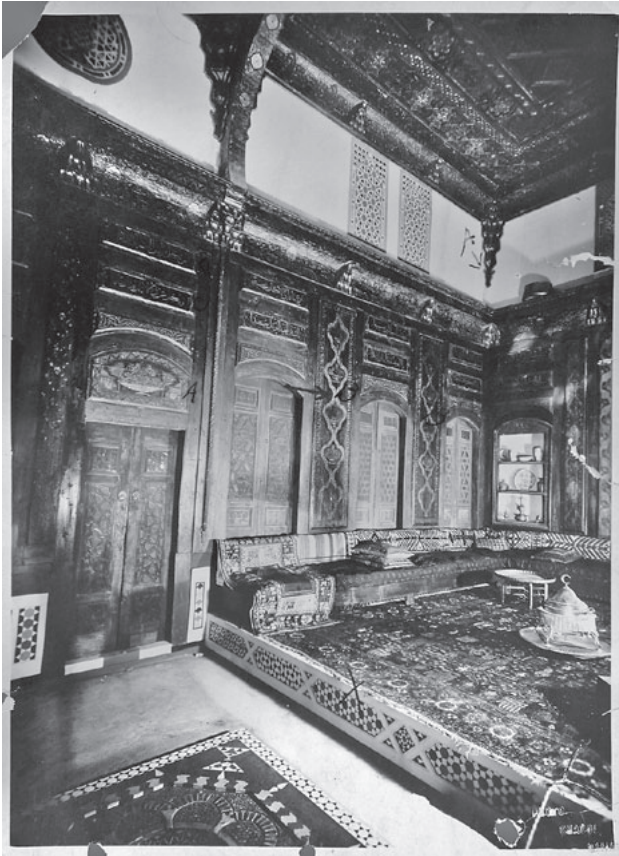
Fig. 2 1930s image of Nur al-Din Room taken before it was disassembled and sold. On the reverse of this image the words ‘Nur ad-Din north side’ are written in Arabic. Image: © The Doris Duke Foundation for Islamic Art.

The entrance section, originally located in the north wall of the *ataba* leading to the courtyard, was moved to the west wall because of gallery space constraints, Figs 2 and 3. The panel with red cupboard doors in the center of the west wall was thus displaced and so moved to the north wall in the *tazar*. The paired vertical panels originally on either side of this cupboard were relocated to opposite walls in the *ataba*.

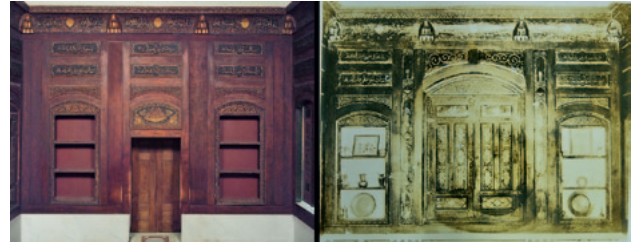
Fig. 3 1970s installation of the west wall (left) showing the relocated entrance doors and 1930s image of the same wall (right), showing the original location of the panel with the red cupboard doors. Images: © The Metropolitan Museum of Art and The Doris Duke Foundation for Islamic Art.

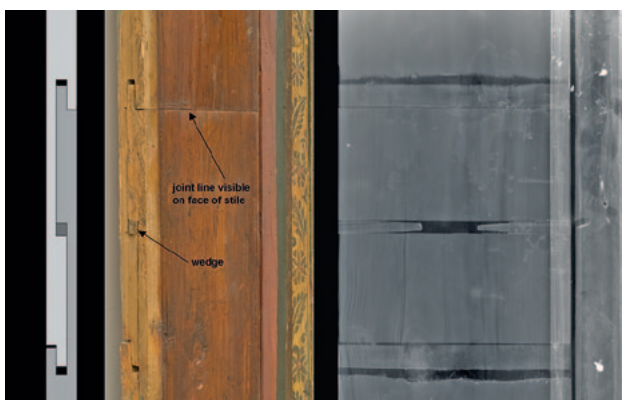
Fig. 4 Tenoned scarf joint of vertical stile: drawing of side view (left), photograph in three-quarter view (center) and X-radiograph taken from the front (right). Drawing: Beth Edelstein, photograph: Mechthild Baumeister; X-radiograph: Timothy Hayes, all © The Metropolitan Museum of Art.

Some interesting construction methods were used in the wall paneling. The walls are clad with 16 independent framed units, in which the vertical stiles are mortised to receive the tenons of the horizontal rails. X-radiographs of the joints revealed that the mortises were coarsely cut, with the tenons held loosely without adhesive or pegs, as is observed throughout the room. Some of the long stiles were created by connecting two cypress boards end-to-end with a tenoned scarf joint, a sophisticated and economical method of joinery, Fig. 4. These joints appear as lines across the front of the stiles at varying heights. The joint was designed to resist both tensile and compressive forces and is locked by the insertion of two wedges, without any adhesive. This joint is seen in other surviving Damascene rooms dated to the eighteenth century, in both vertical and horizontal frame members.

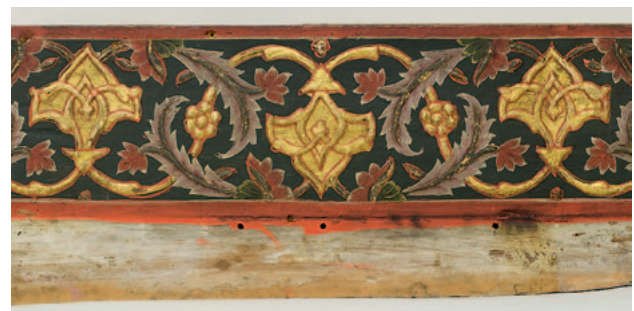
Fig. 5 Detail of *'ataba* ceiling panel with gilded and tin-leaved *'ajami* against a smalt background. Note the corrosion of the unglazed tin leaf and the discolored smalt; other colors are more representative of the original palette. Image: Mechthild Baumeister © The Metropolitan Museum of Art.

The original palette of the decorated surfaces was dominated by bright colors combined with reflective metal leaf to produce a variety of surface effects, Fig. 5. Broad fields of bright red, lustrous orange and vibrant green were embellished with finely painted vines and flowers, while gilded *'ajami* calligraphy, scrollwork, and serrated leaves flowed across brilliant blue backgrounds. These surfaces are now largely obscured by darkened varnish layers, applied periodically while the room was in its original location. The presence of varnish also complicated the interpretation of analytical data. Where possible, samples for material analysis were taken from protected areas revealed when the room was disassembled.

All surfaces were varnished, although fewer layers were applied to the upper cornices and ceilings, Fig. 5. Py-GC-MS results from samples removed from both decorated and unpainted surfaces and from metal hinges confirm that these varnish layers, like the original glazes, are drying oil and *Pinaceae* resin mixtures.

The corroded tin leaf produces disruptive changes to color and texture over large areas, particularly where the tin is unglazed, Figs 5 and 6. Viewed in cross-section the tin appears to have corroded to varying degrees even where protected by glazes

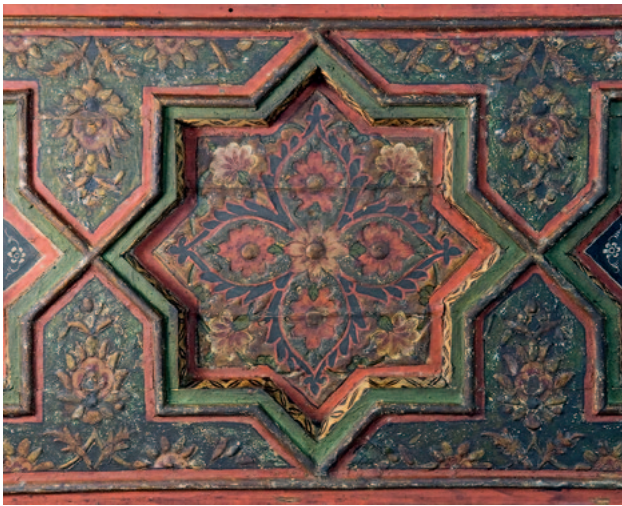
Fig. 6 Detail of *tazar* ceiling panel, showing the use of 'ajami to create raised relief decoration in the background areas and sunken relief within the recessed 8-pointed star. The 'ajami is decorated with tin leaf and glazes. Image: Mechthild Baumeister © The Metropolitan Museum of Art.

simply by wetting the *'ajami* paste. Gold was used mainly for significant *'ajami* decorations, such as the calligraphy and the medallions, and for the *muqarnas* decoration. In contrast, tin leaf was applied over large areas, usually coated with transparent green, red, orange or yellow glazes to produce shimmering effects. Occasionally the silvery surface was left exposed. Where the glazed tin was used together with painted decoration, both tin and glaze layers are present under the paint, Figs 6 and 7a. This feature reflects both the low cost of tin and the efficient method employed for working on a large scale. Where tin leaf is decorated with patterns executed in colored glazes, the outline was first painted in black, Fig. 8a. The red and green glazes were also used over opaque paints to add depth and contour to flowers, or for small decorative motifs, Fig. 6.

The most complex condition issues regarding the 'ajami decoration are the aged varnish layers and the widespread tin corrosion, both of which impact negatively on the overall appearance of the room and the stability of original surfaces, Fig. 6. The varnish has solubilized and intermingled with the orange glaze, leaving a rough texture with raised, darkened 'islands' where the glaze-varnish mixture has contracted, Figs 7a and 8. The yellow, red and green glazes, though often deteriorated, have not interacted with the varnishes in this way, suggesting that the composition may have influenced the solubility of the orange glaze, Fig. 8.<sup>4</sup> All surfaces have been adversely affected by tension created by the multiple varnish layers, causing extensive flaking and loss to the glaze, tin leaf and paint layers. This is most pronounced in the glazed tin leaf decoration, Fig. 6.
